Brownfields Remediation

in Delaware County, PA

**Environmental Studies Capstone
Seminar**

Swarthmore College

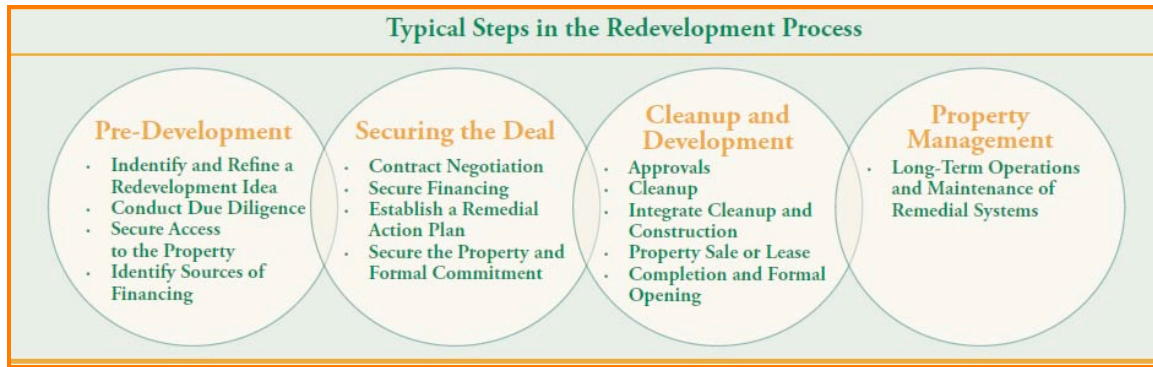
Figure 1: Typical steps in the redevelopment process *Anatomy of Brownfields Redevelopment* EPA

Redevelopment plans are often the driving force behind remediation efforts. The stakeholders can be from a variety of different backgrounds. Individuals and groups from the private and public sectors can collaborate to initiate redevelopment. Remediation plans can be one part of the redevelopment plan along with securing financial and contractual agreements. The EPA *Anatomy of Brownfields* publication lays out a clear and concise diagram indicating typical stages of redevelopment.

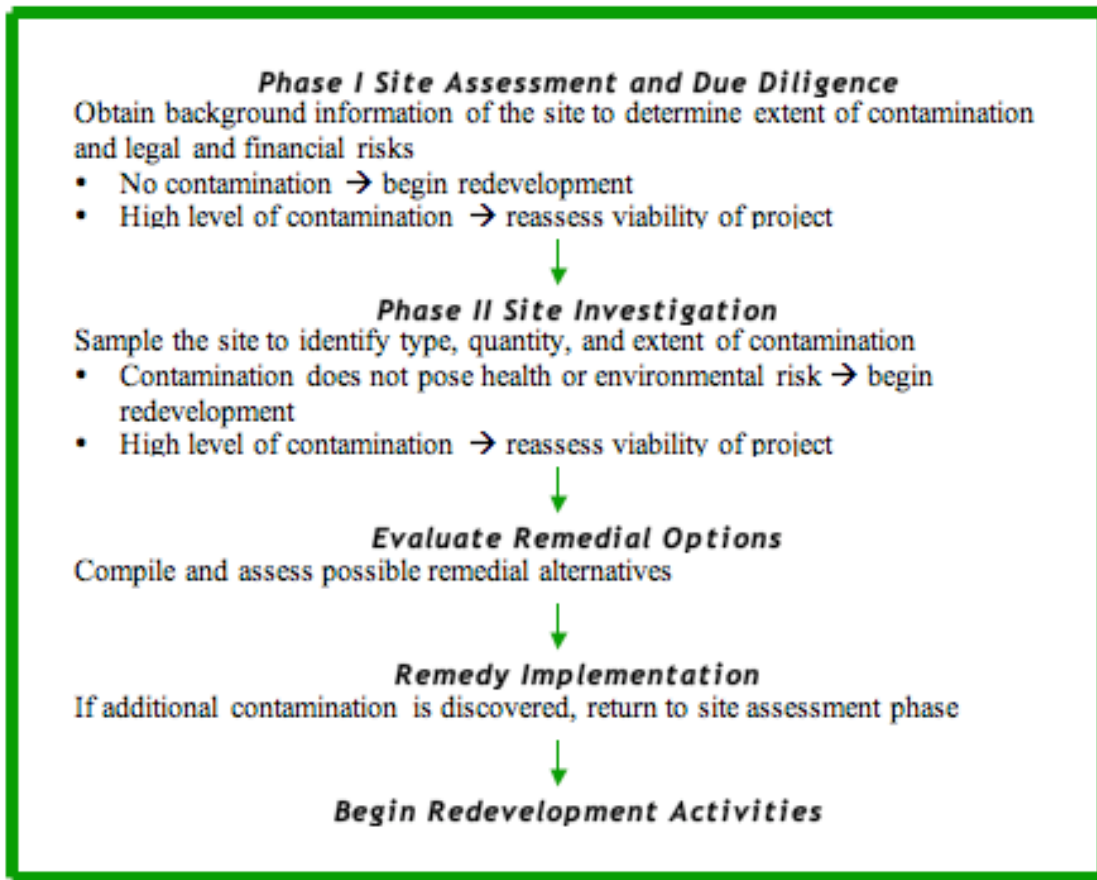
Figure 2 Flow chart of the redevelopment process²⁷

This section of the report focuses on the approaches and methods utilized to characterize the brownfield site and future possibilities for remediation. Often before this process even begins, brownfield developers will have an idea for the future development of the site—what the final plan for the land will be. This provides the framework for how in depth and precise the site assessments will need to be, and will determine the level of cleanup and remediation needed. With this framework, the site assessment and investigation processes will generate the data required to make an informed decision on how to proceed with cleanup and redevelopment.

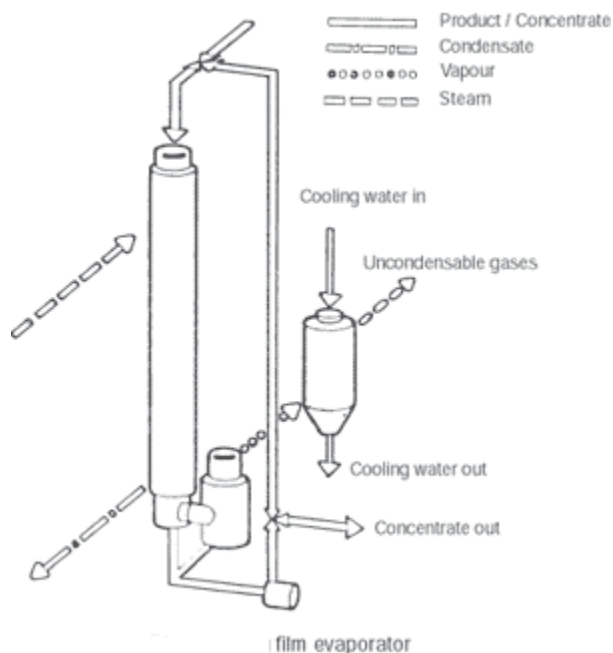
Evaporation is a technique that allows for the separation of volatile compounds from nonvolatile components and is used to remove solvents from solids or semisolids. There are two technologies of evaporation equipment: thin-film evaporators and dryers. Thin-film evaporators have the fluid enter a rotating heated conical receiver and the centrifugal force causes the fluid to travel towards the outer edge where it is collected and drawn off as residue. The volatile components that evaporate from the heating in the process are condensed on a chiller and then collected and contained. Dryers serve as large rotating heated drums that allow volatile compounds to evaporate. For wastewater containing non-volatile compounds and that contains salts or dissolved solids, aqueous evaporation is a technique that minimizes the volume of waste requiring disposal—that is excess water is evaporated in the previous methods to reduce the total volume of the water.

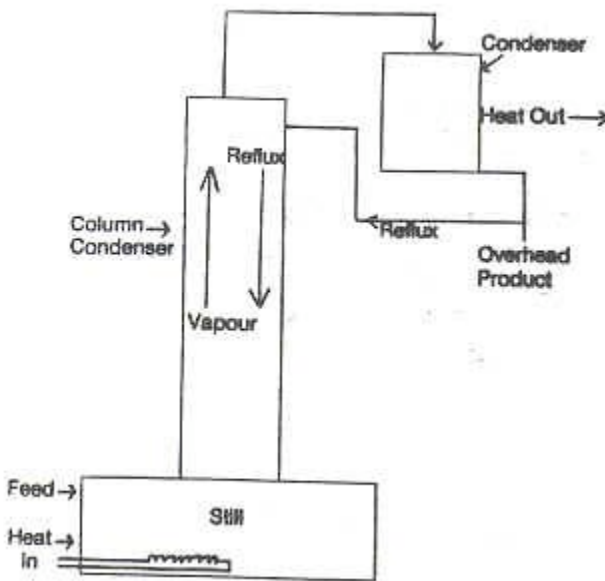
Distillation technology allows the operator to remove contaminants from a solvent (i.e. water) waste stream. This technique exploits differences in vapor pressures or boiling points between the water and the impurity. If a volatile compound has a higher boiling point than the water it is dissolved in, the water volatilizes before the impurity, leaving only the impurity.

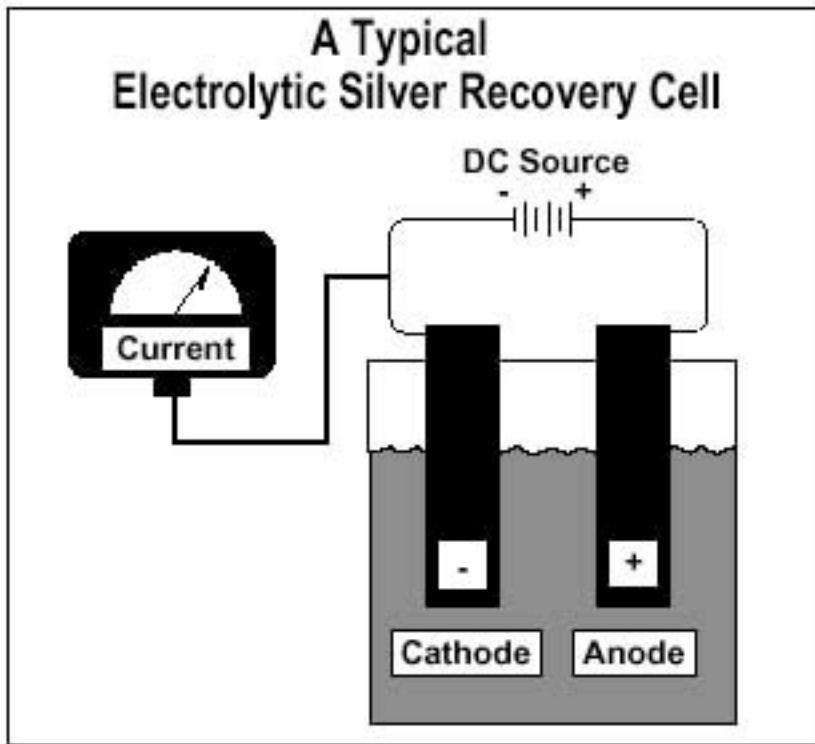
For dealing with metal ions, a cell consisting of an anode and a cathode immersed in the wastewater will collect the harmful metal ions in a process known as electrolytic recovery.

The metal ions are attracted to the anode and can be collected and contained.

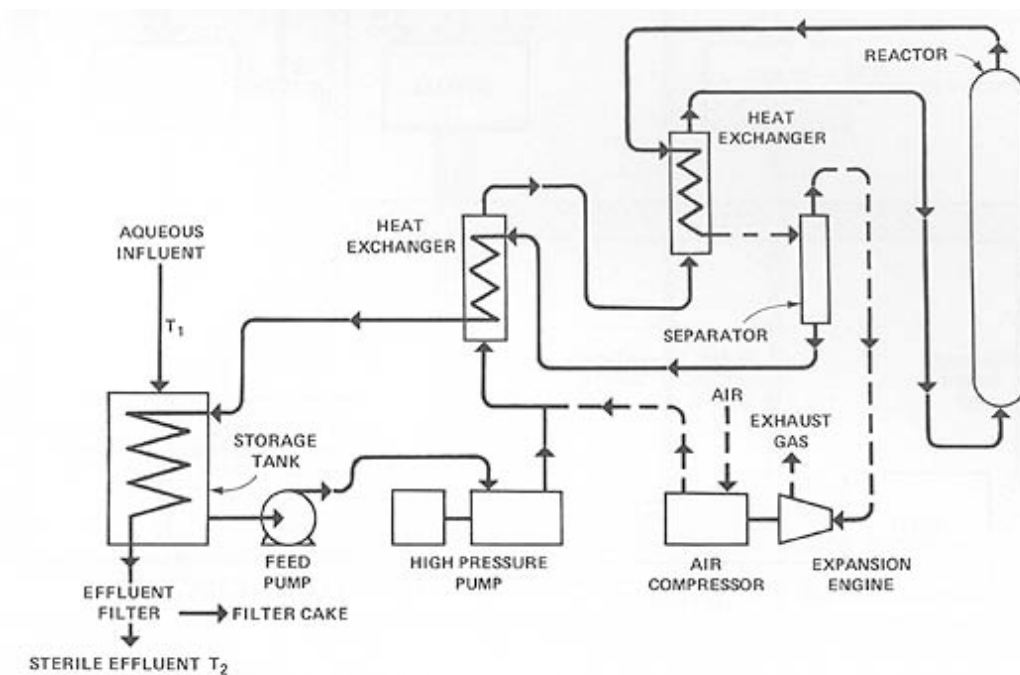
Figure 5-14.— Continuous wet oxidation process.

In this hydrothermal treatment, compressed air is injected into a super-heated (175-325 °C), pressurized system to oxidize organic contaminants in wastewater.

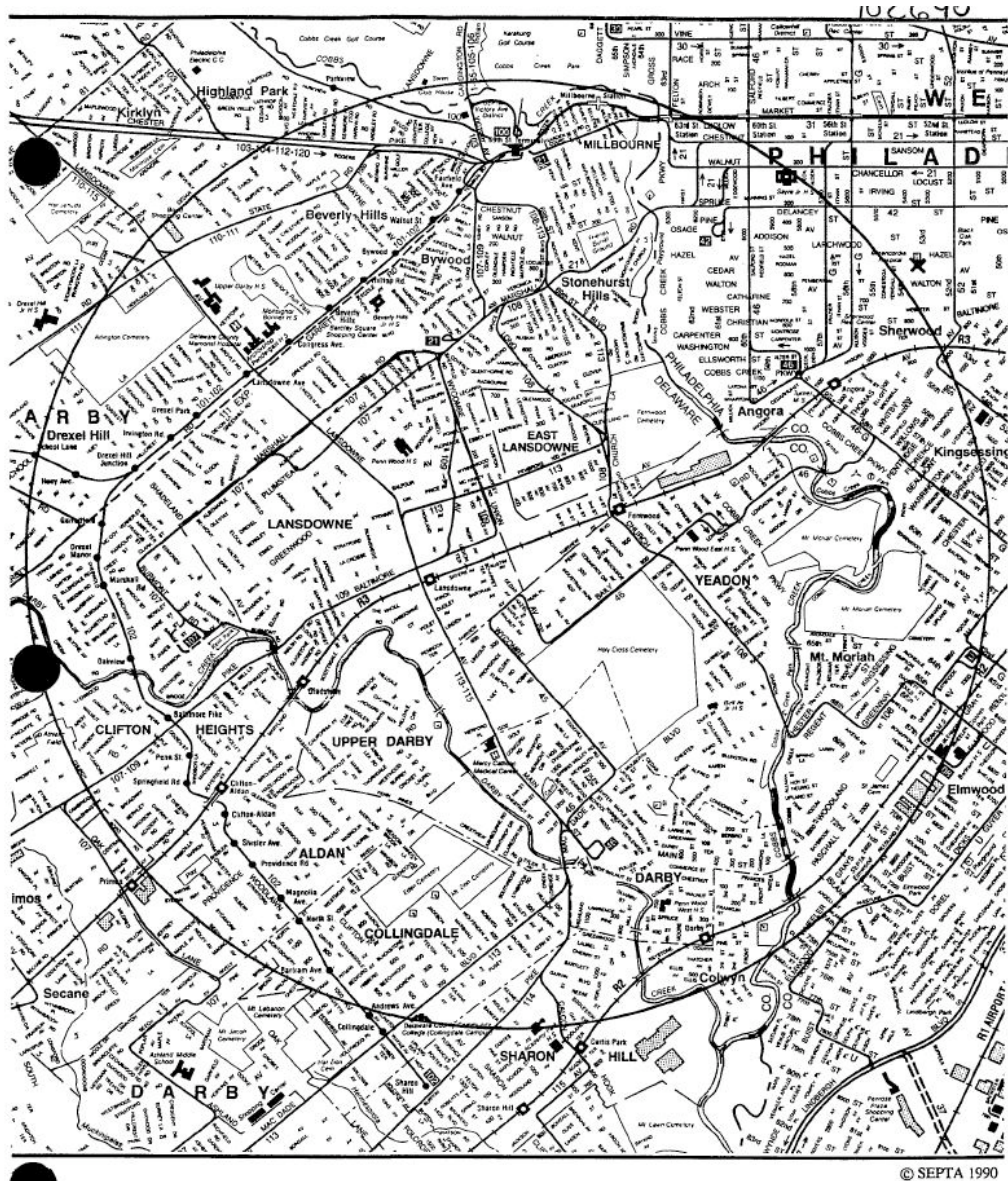
Figure 8: Map of the two mile radius where the EPA's scanner van was deployed (Original Source: SEPTA 1990)

The map above of eastern Delaware County outlines the two-mile radius where EPA's scanner van was deployed for radium.
